GOVERNMENT OF INDIA  
MINISTRY OF CIVIL AVIATION  
(COMMISSION OF RAILWAY SAFETY)

# RAILWAY ACCIDENT INVESTIGATION REPORT

**DERAILMENT OF 1034 UP LUCKNOW-BOMBAY VT PUSHPAK EXPRESS  
(DIESEL ENGINE HAULED) AT KM. 1256/0-1 BETWEEN ATA AND ORAI  
STATIONS ON THE JHANSI-KANPUR SECTION OF JHANSI DIVISION  
OF CENTRAL RAILWAY AT 11.08 HOURS ON 17.05.1994.**

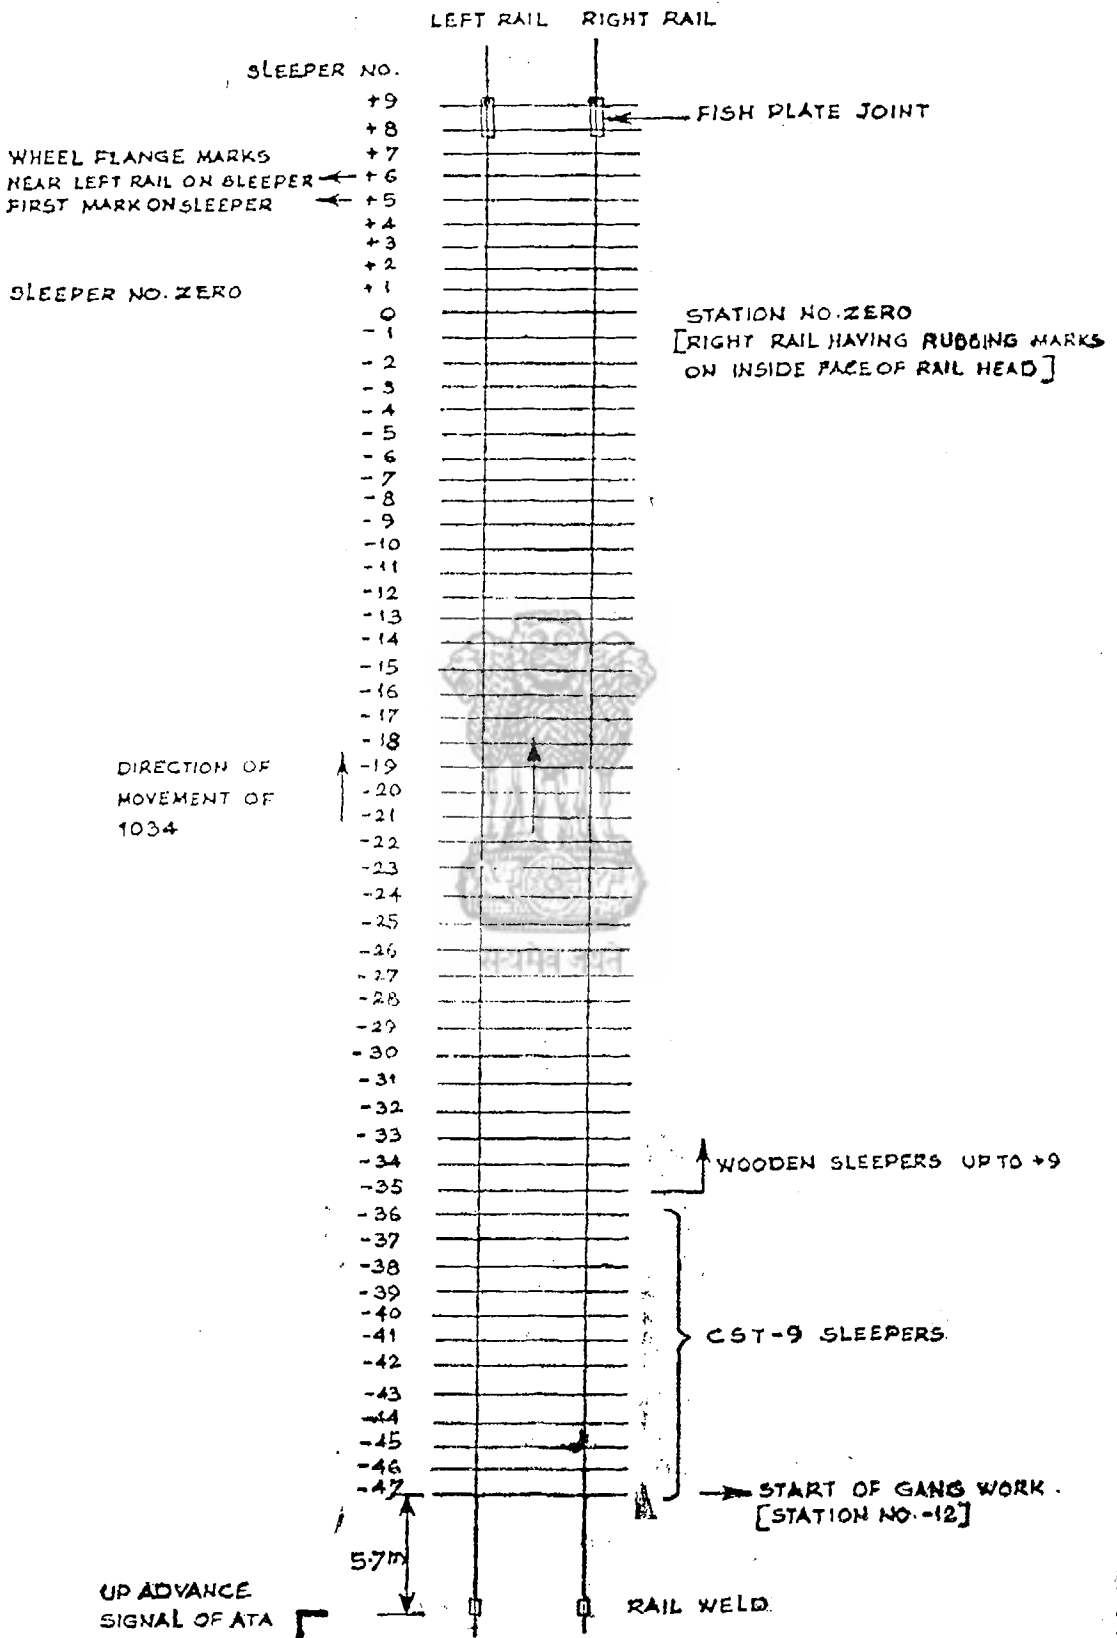
# B. DETAILS OF SLEEPER NEAR POINT OF DROP

Sleeper No.	Left rail fitting	Right rail fitting	Ballast	Sleeper type	Remarks
+9	Sleeper damage spikes worked out	Rail out of position	Shifted	Wooden ACB plates round spikes	Flange marks on sleeper near left rail.
+8	Sleeper cracked and one spike missing	Rail shifted all spikes broken from chair & sleeper cracked	"	"	Distance of flange mark different on sleeper No. 8 & 9 from rail foot.
+7	Sleeper crack	Chair sheet damaged	"	"	—
+6	Key missing	spike loose	"	"	Flange mark on sleeper near left rail
+5	Spike loose	spike loose key missing	"	"	First mark on wheel flange drop on sleeper near left rail. On right rail, rubbing impression on foot of rail.
+4	spike loose key loose	spike loose	"	"	—
+3	spike loose	spike loose	"	"	On rail foot, ACB plate & key rub mark noticed on right rail inside.
+2	spike loose	do.	"	"	do.
+1	spike little loose	do.	"	"	Rubbing mark on right rail foot inside.
0	spike loose	one key missing	OK	"	Right rail rubbing mark on rail head inside face
